## Results of Substation Insulator Testing

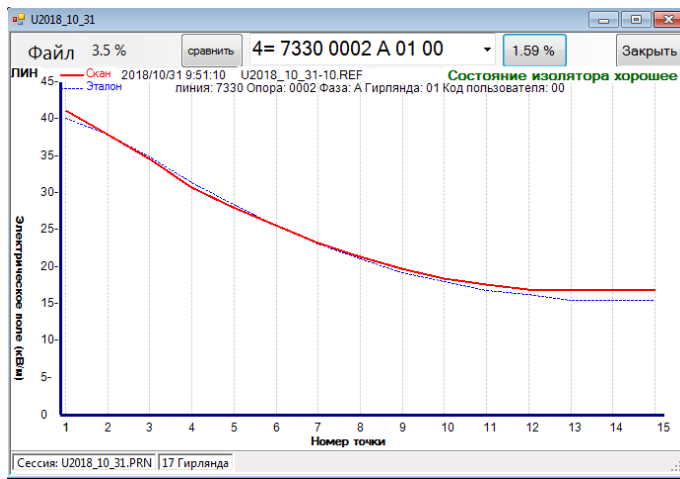
Deviation = 1.59 %

Phase A, no defect

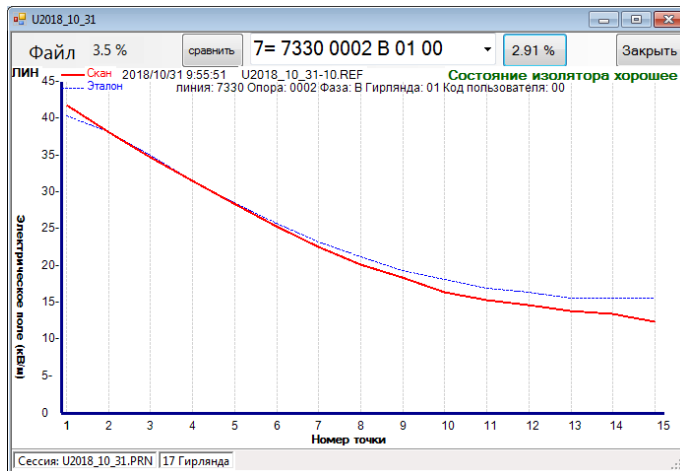
Deviation = 2.91 %

Phase B, no defect

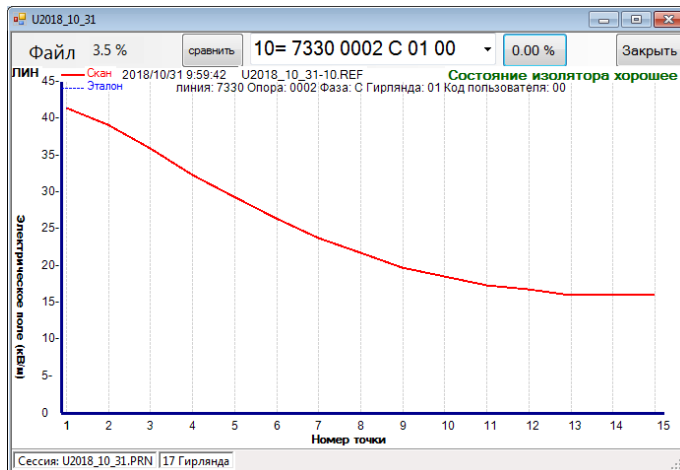
Reference

Phase C, no defect

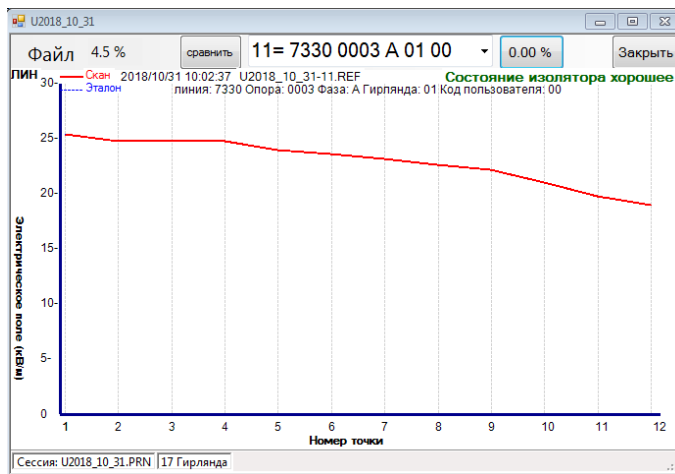
Reference

Phase A, no defect

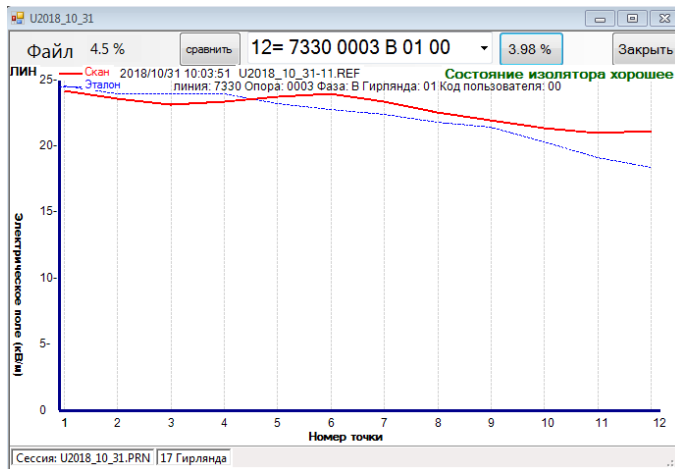
Deviation = 3.98 %

Phase B, no defect

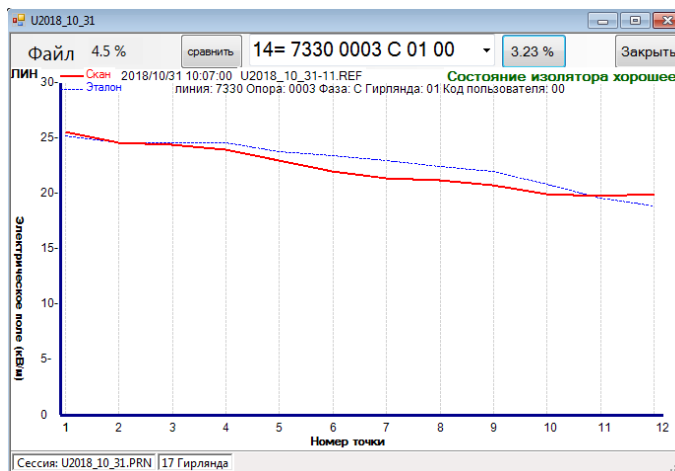
Deviation = 3.23 %

Phase C, no defect

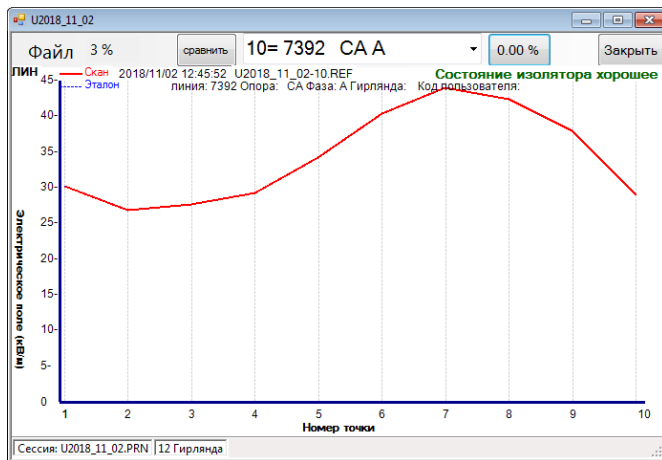
Reference

Phase A, no defect

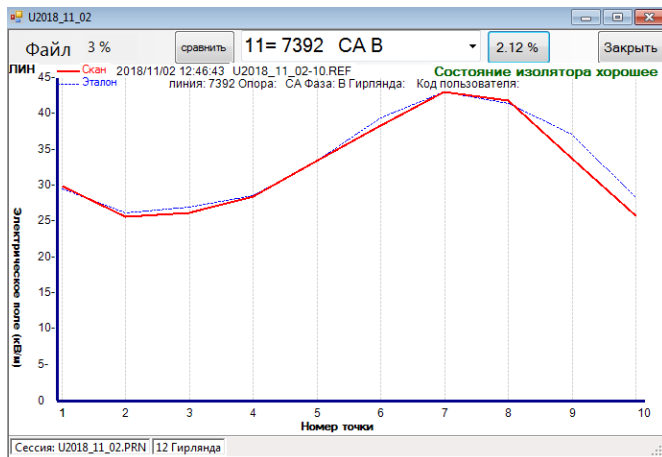
Deviation = 2.12 %

Phase B, no defect

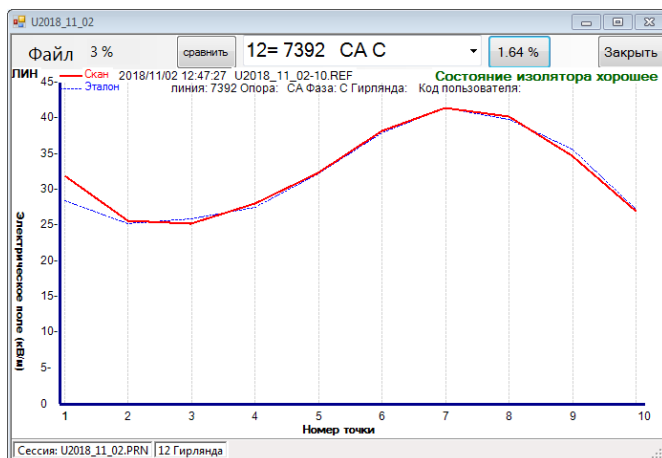
Deviation = 1.64 %

Phase C, no defect

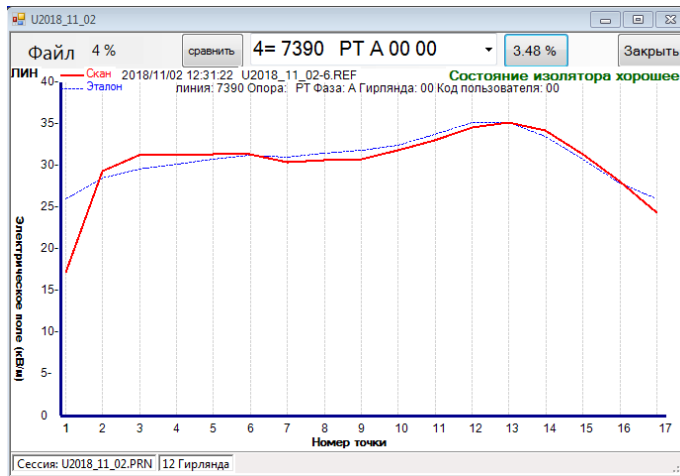
Deviation = 3.48 %

Phase A, no defect

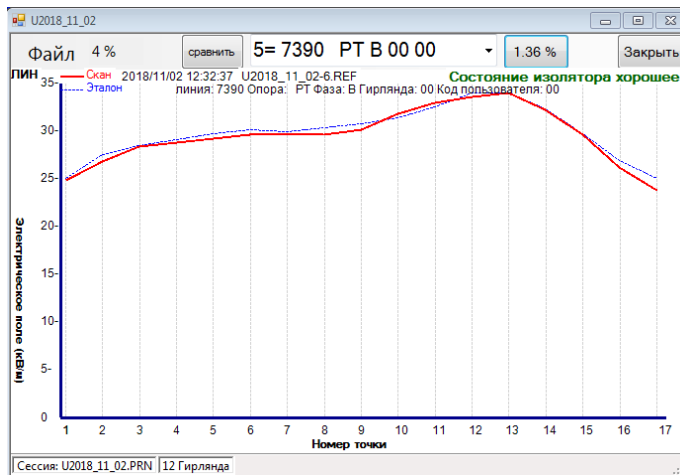
Deviation = 1.36 %

Phase B, no defect

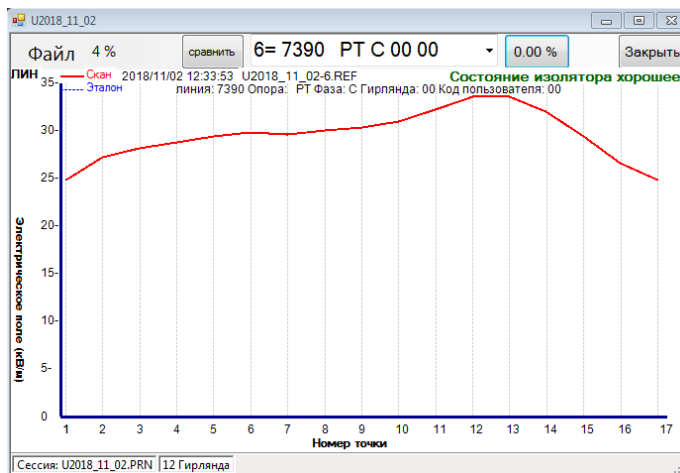
Reference

Phase C, no defect

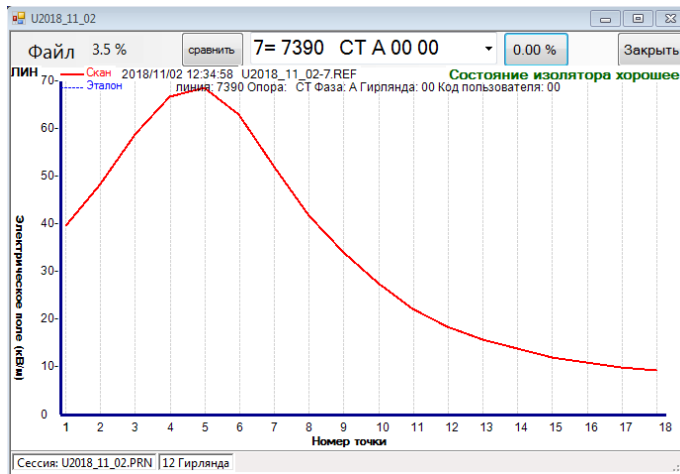
Reference

Phase A, no defect

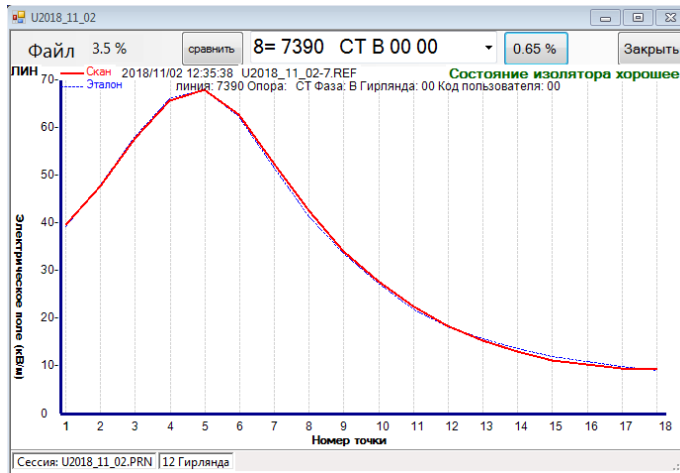
Deviation = 0.65 %

Phase B, no defect

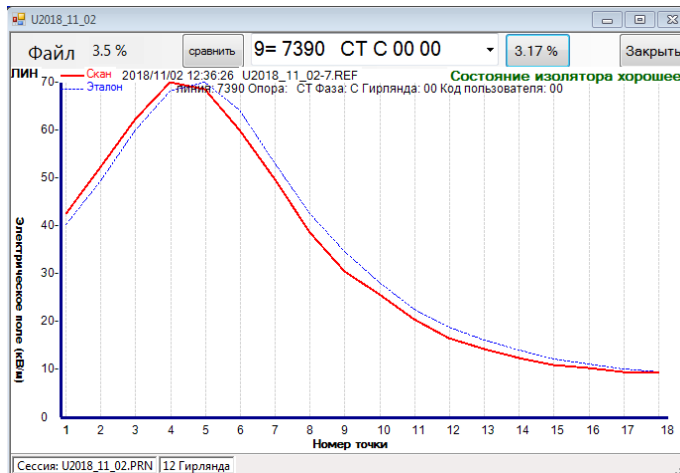
Deviation = 3.17 %

Phase C, no defect

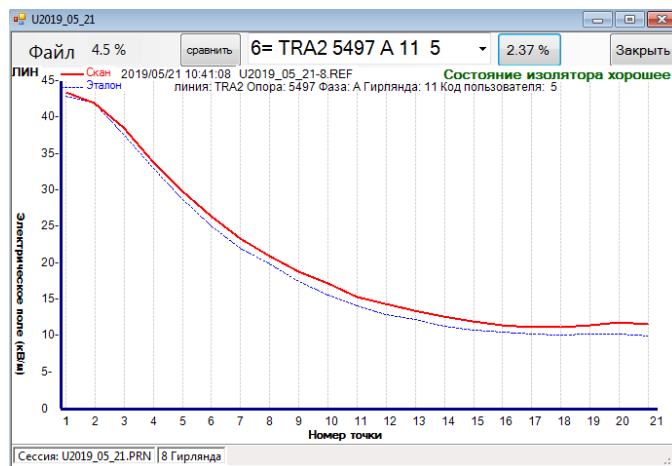
Deviation = 2.37 %

Phase A, no defect

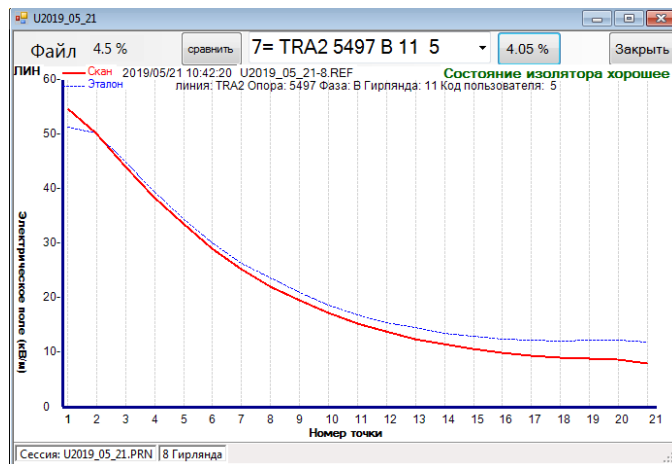
Deviation = 4.05 %

Phase B, no defect

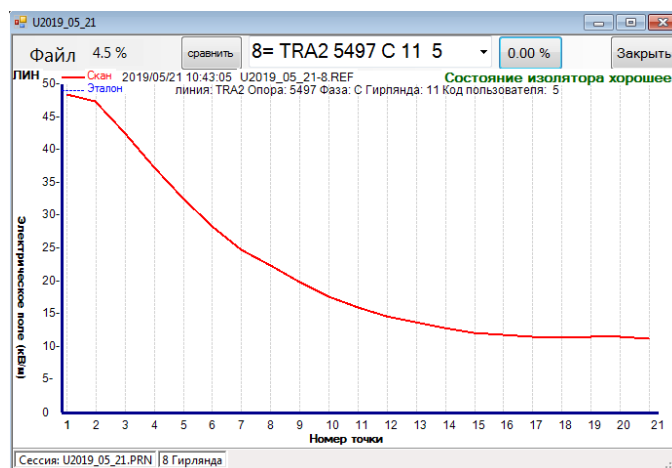
Reference

Phase C, no defect

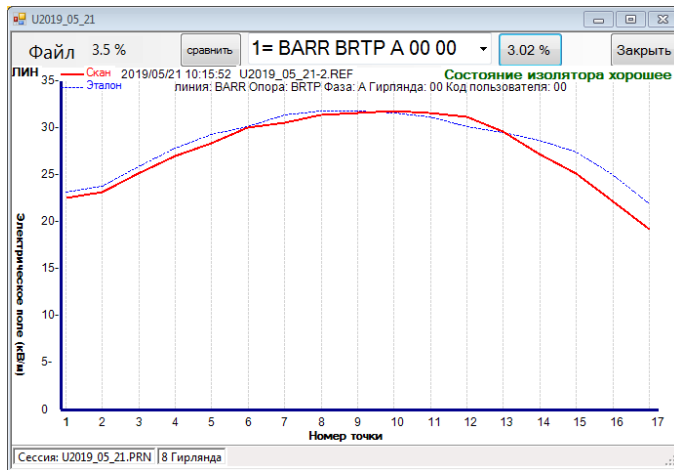
Deviation = 3.02 %

Phase A, no defect

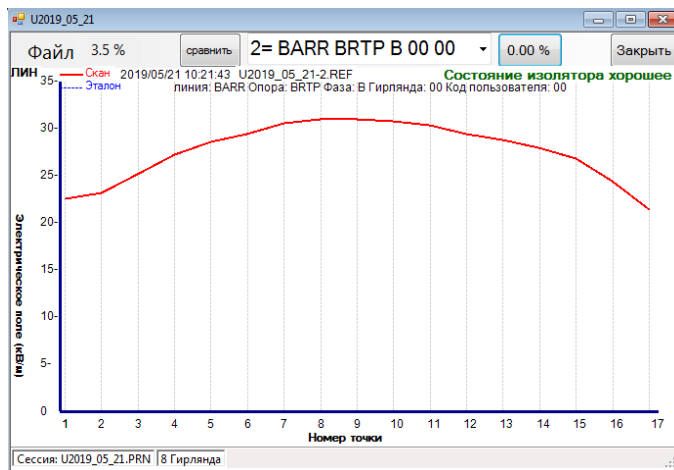
Reference

Phase B, no defect

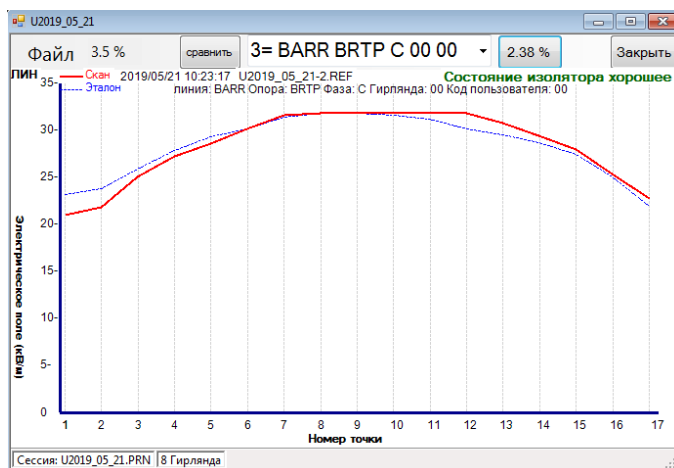
Deviation = 2.38 %

Phase C, no defect

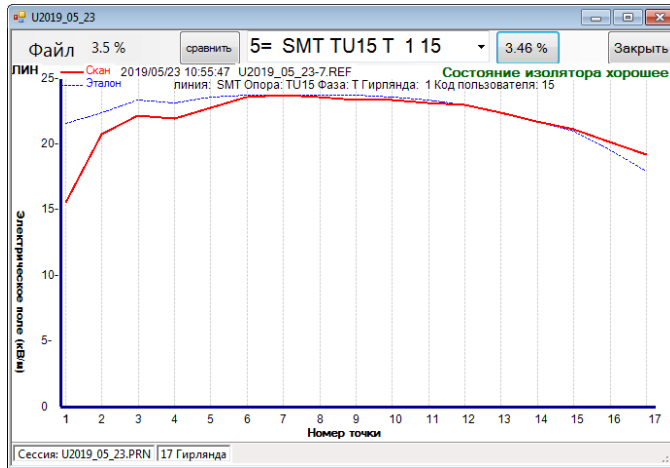
Deviation = 3.46%

Phase T, no defect.

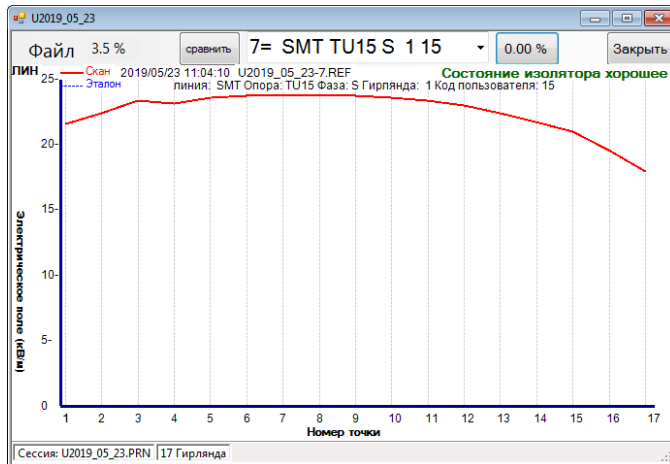
Reference

Phase S, no defect.

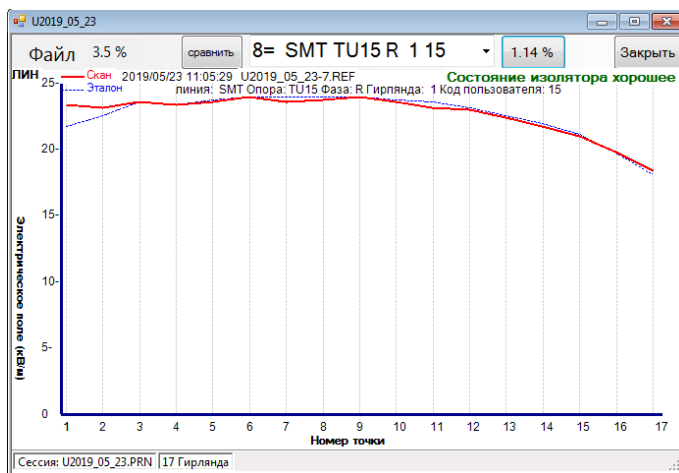
Deviation = 1.14 %

Phase R, no defect.

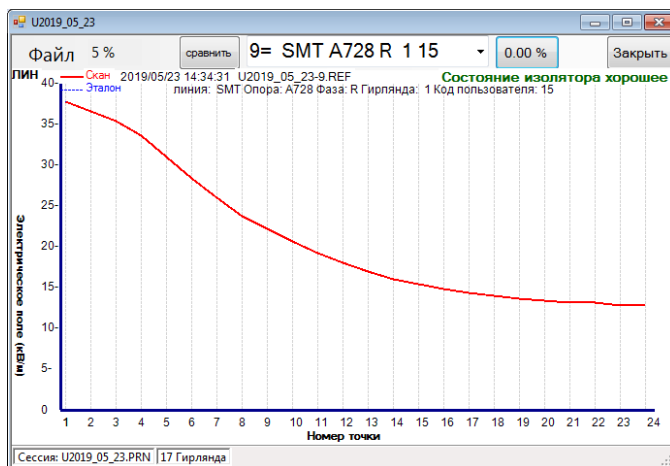
Reference

Phase R, no defect.

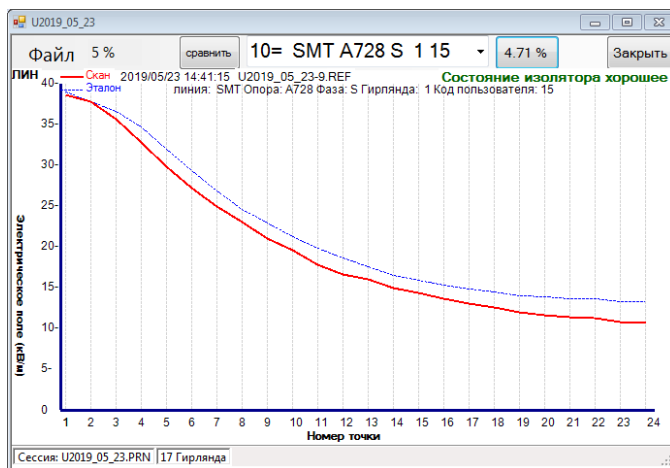
Deviation = 4.71 %

Phase S, no defect.

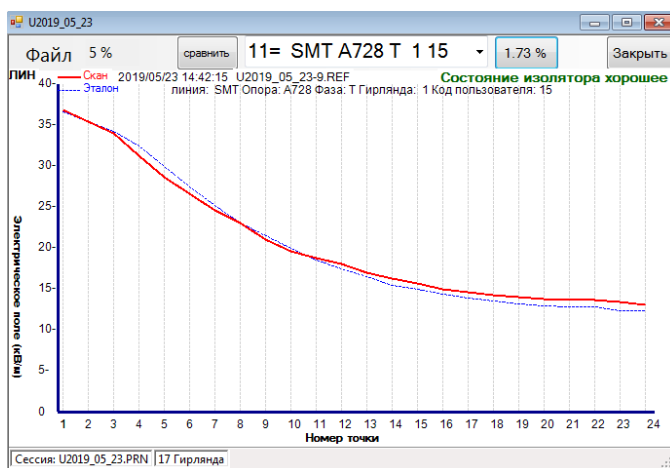
Deviation = 1.73 %

Phase T, no defect.

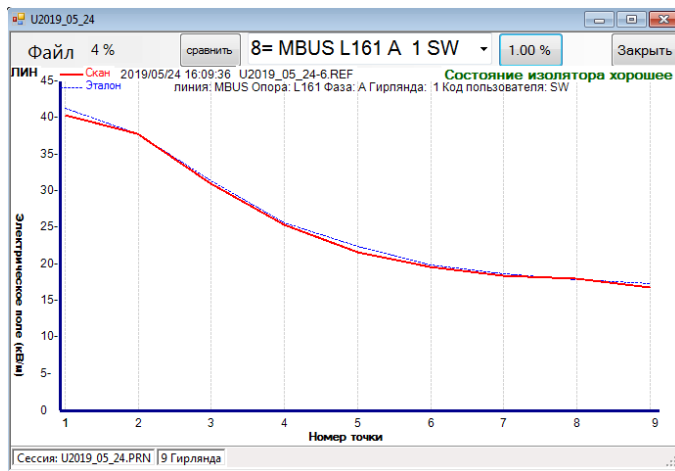
Deviation = 1.00 %

Phase A, no defect.

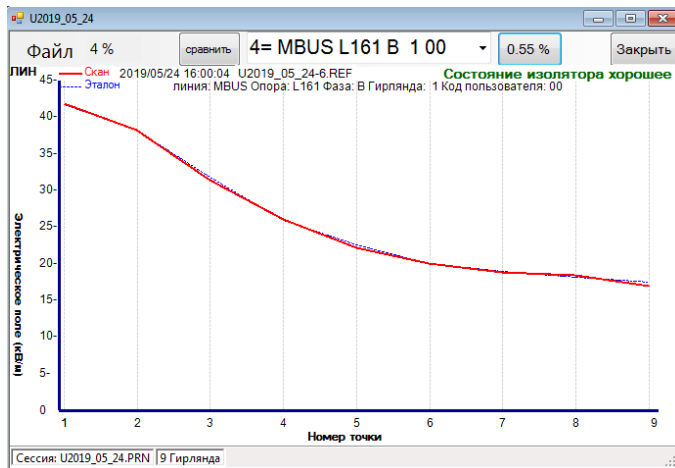
Deviation = 0.55 %

Phase B, no defect.

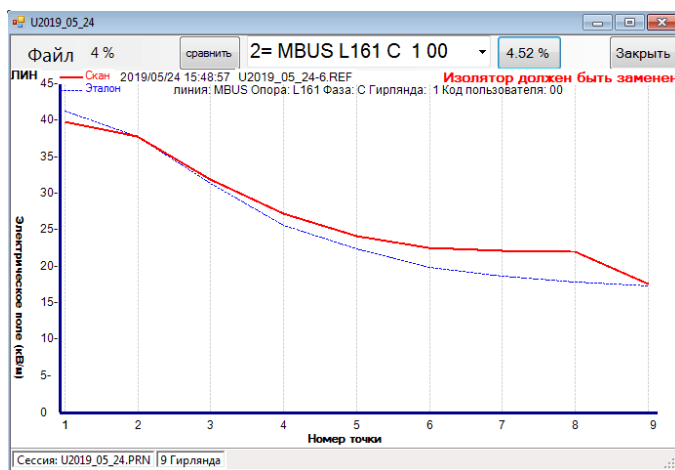
Deviation = 4.52 %

Phase C, broken skirt near the base

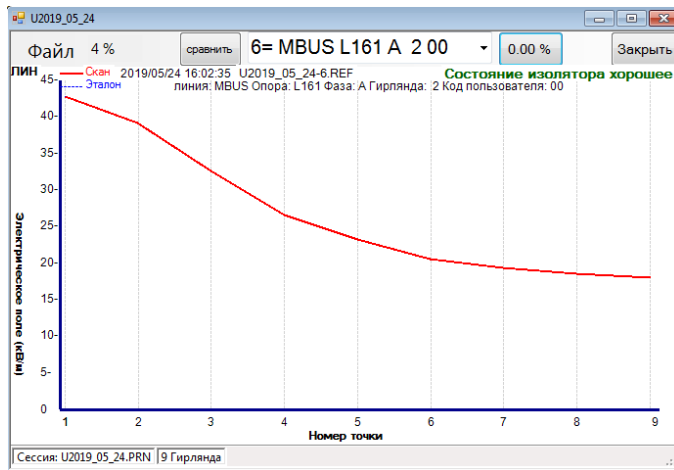
Reference

Phase A, no defect.

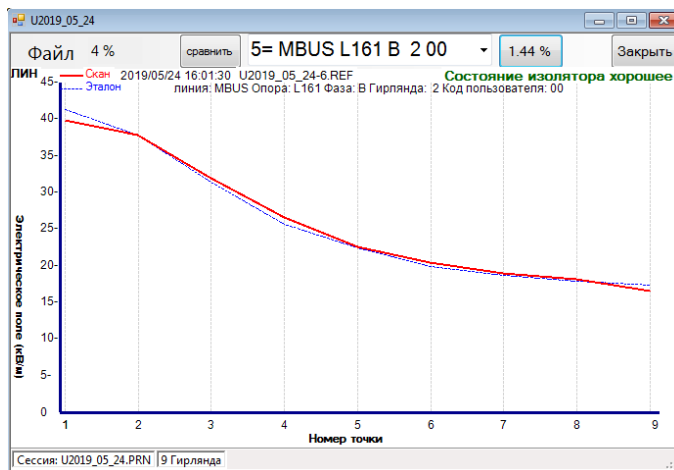
Deviation = 1.44 %

Phase B, no defect

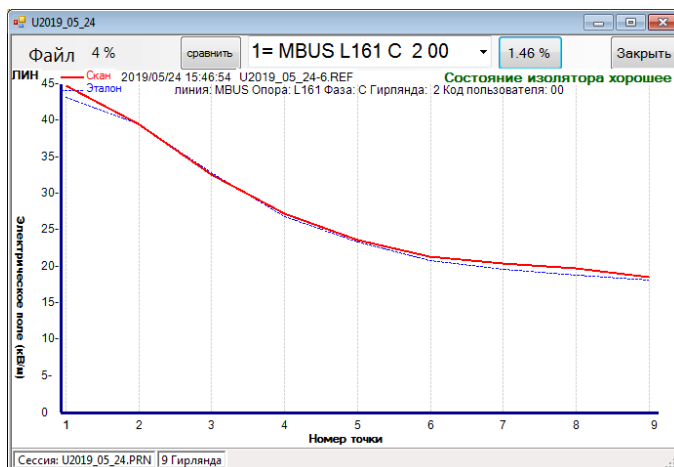
Deviation = 1.46 %

Phase C, no defect

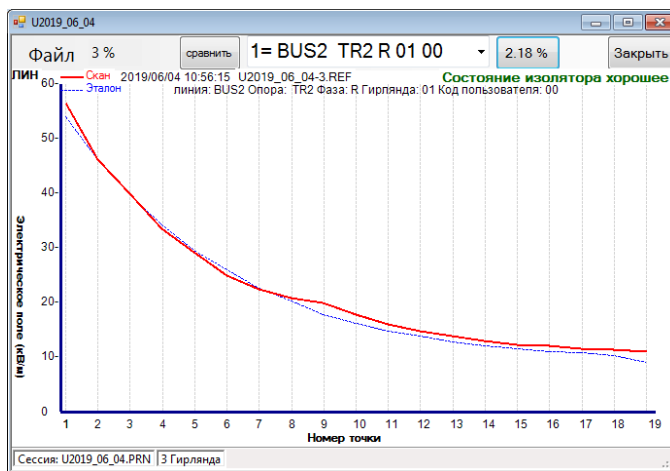
Deviation = 2.18 %

Phase R, no defect

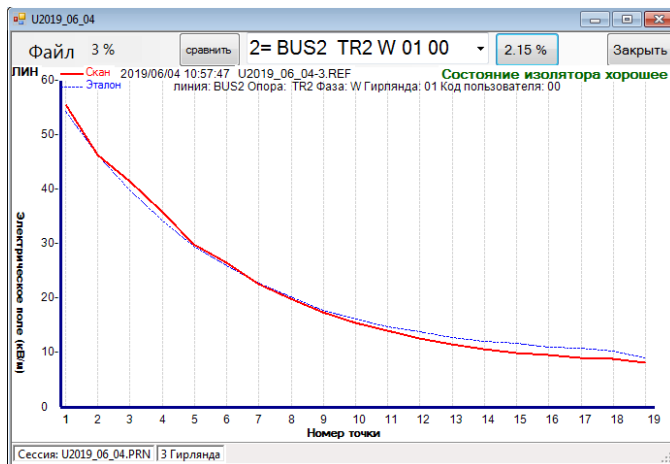
Deviation = 2.15 %

Phase W, no defect

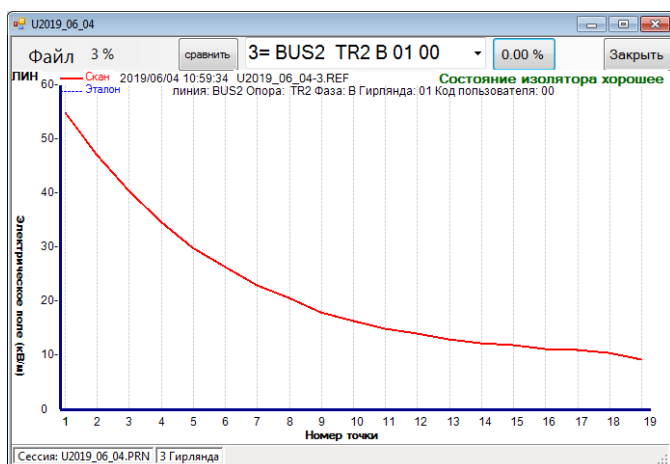
Reference

Phase B, no defect

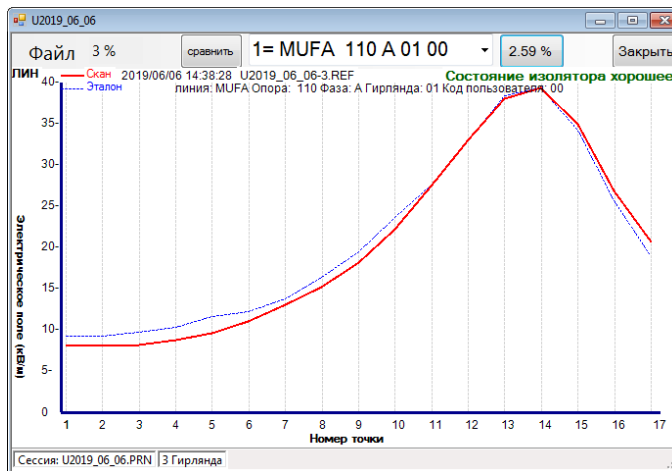
Deviation = 2.59%

Phase A, no defect.

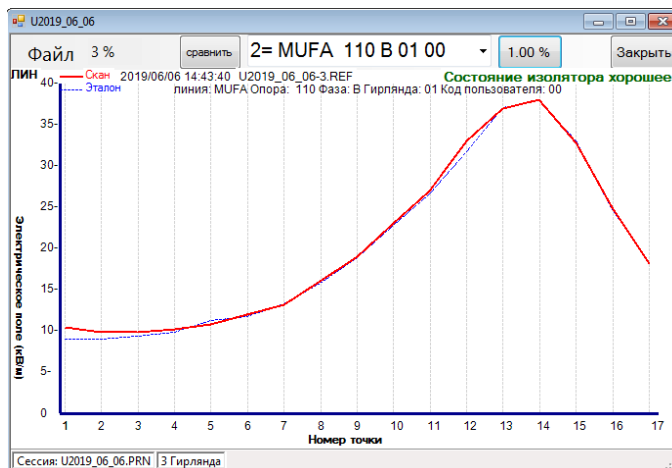
Deviation = 1.00%

Phase B, no defect.

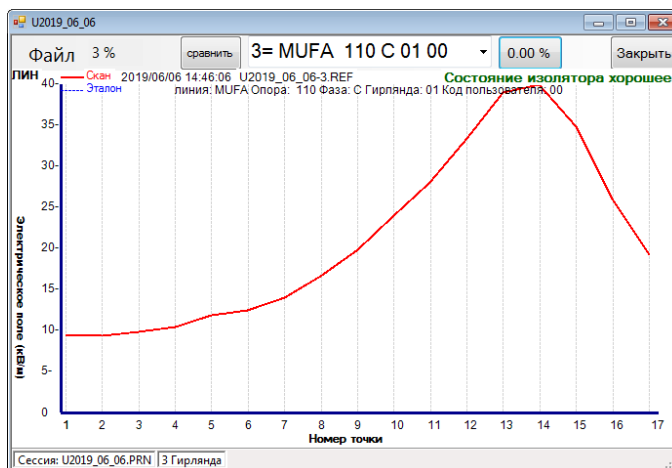
Reference

Phase C, no defect.

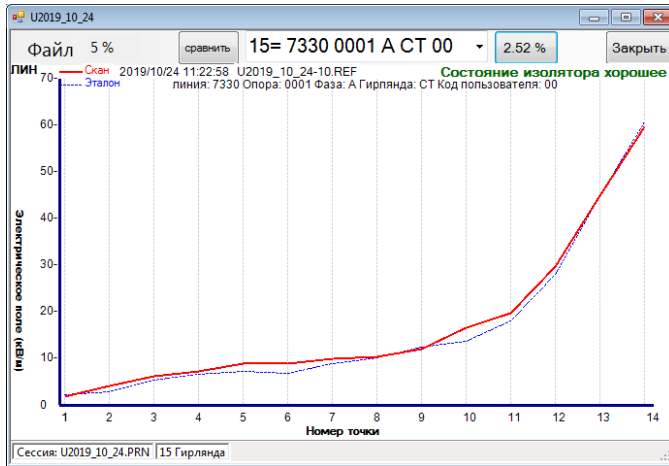
Deviation = 2.52 %

Phase A, no defect

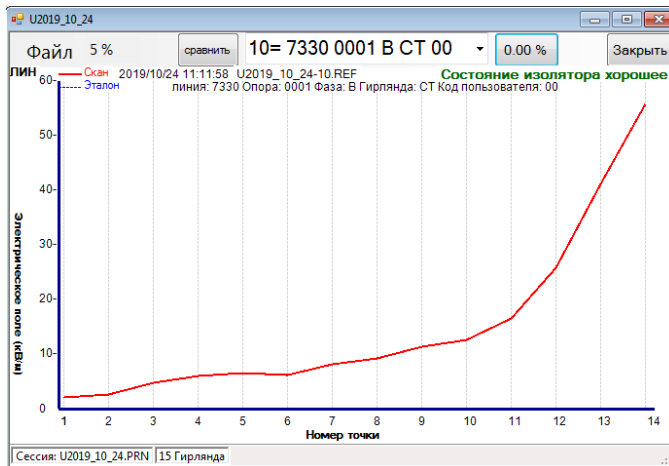
Reference

Phase B, no defect

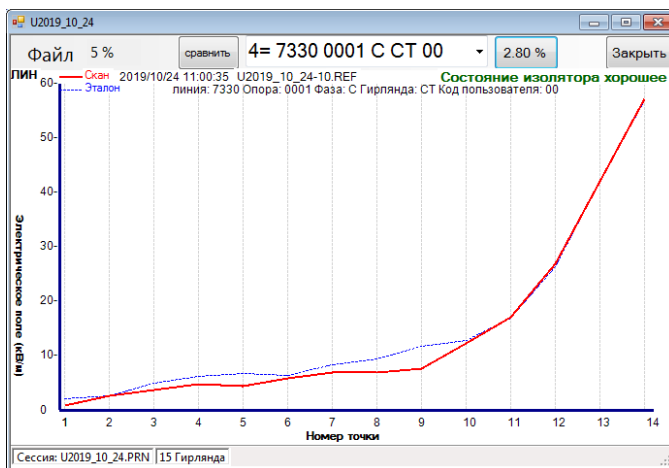
Deviation = 2.80 %

Phase C, no defect

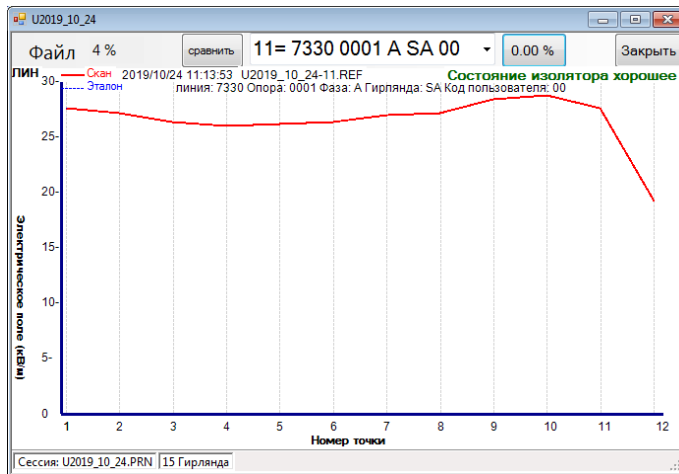
Reference

Phase A, no defect

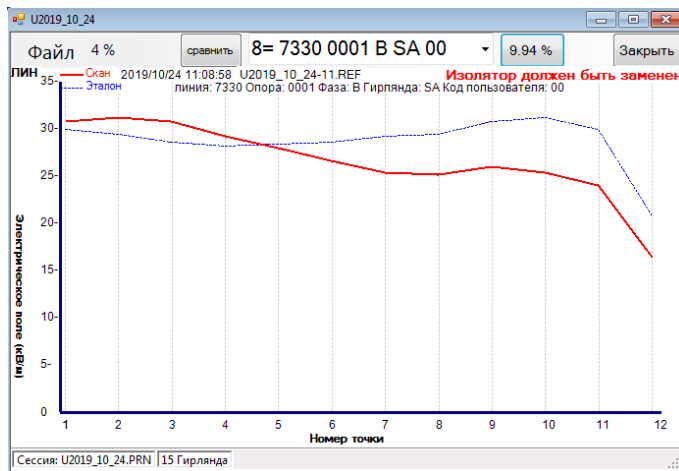
Deviation = 9.94 %

Phase B, bad arrester with  
trace of flashover

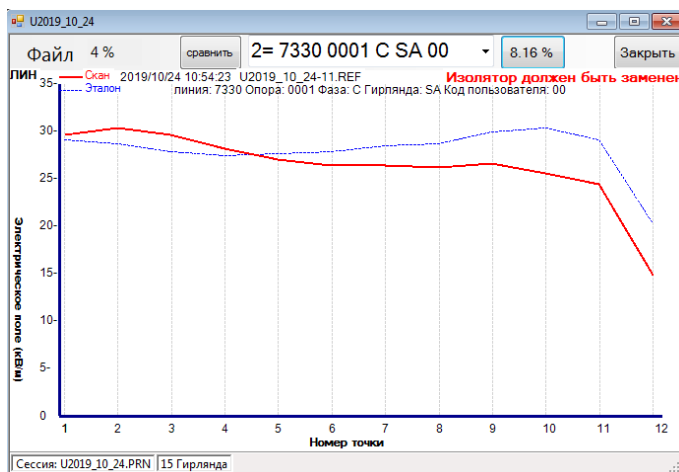
Deviation = 8.16 %

Phase C, bad arrester

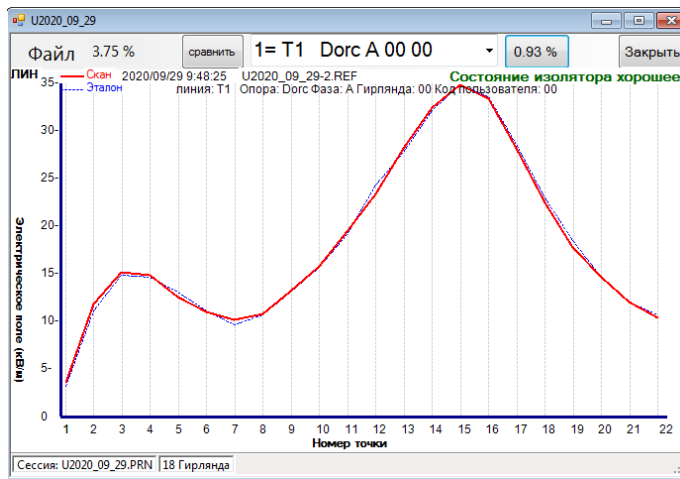
Deviation = 0.93%

Phase A, no defect.

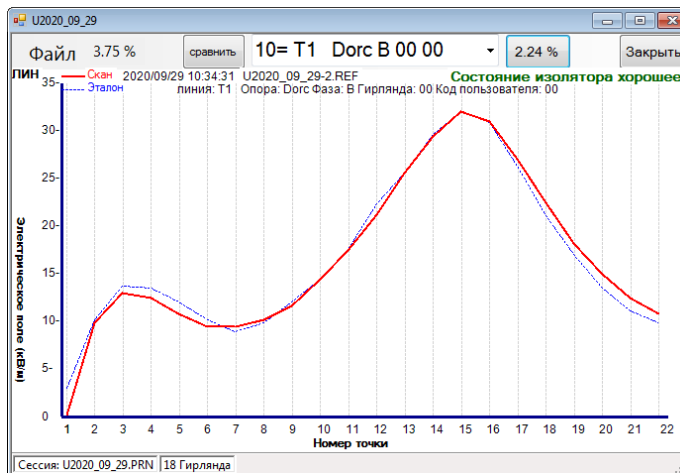
Deviation = 2.24%

Phase B, no defect.

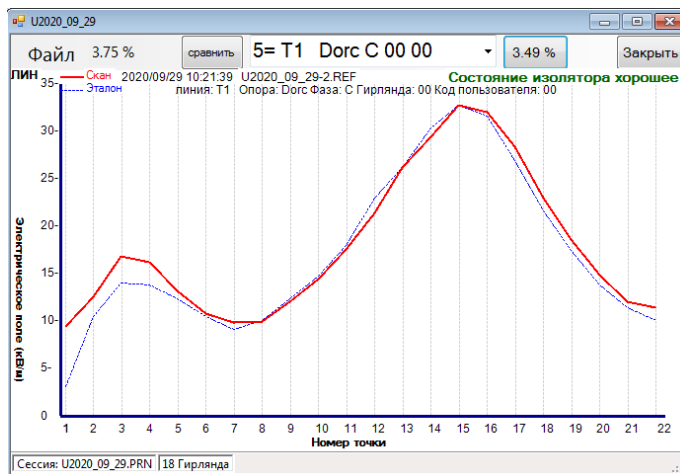
Deviation = 3.49%

Phase C, oil level to check.

Positron recommended testing it again in one year.

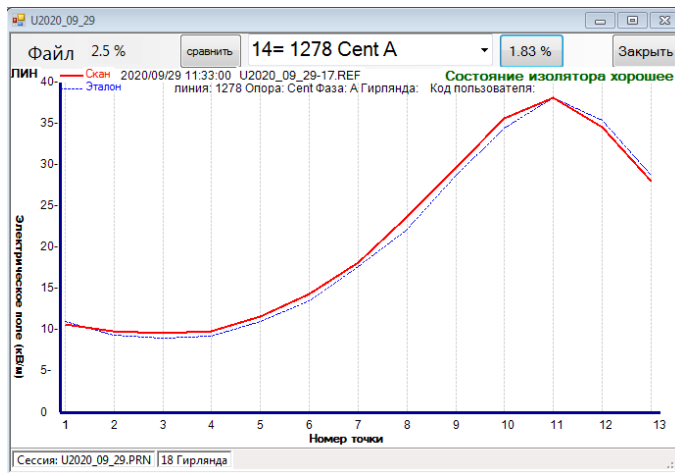
Deviation = 1.83%

Phase A, no defect.

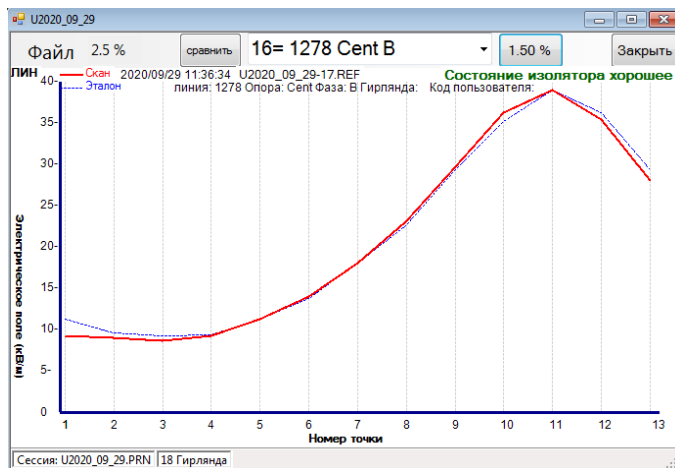
Deviation = 1.5%

Phase B, no defect.

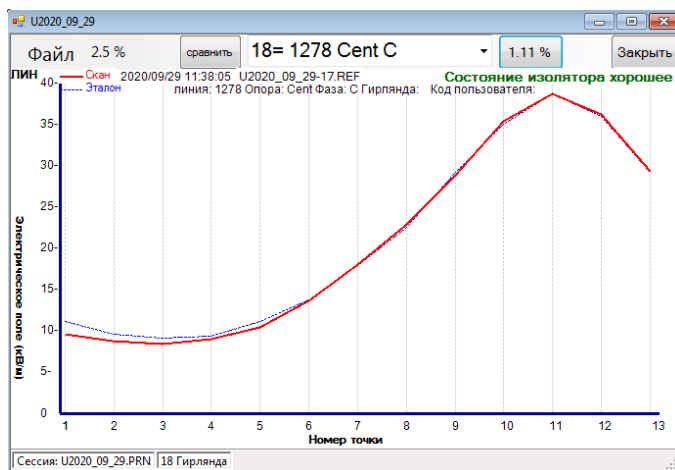
Deviation = 1.11%

Phase C, no defect.
